REPAIR, EVALUATION, MAINTENANCE, AND
REHABILITATION RESEARCH PROGRAM

TECHNICAL REPORT REMR-CO-1

STABILITY OF RUBBLE-MOUND
BREAKWATER AND JETTY TOES;
SURVEY OF FIELD EXPERIENCE

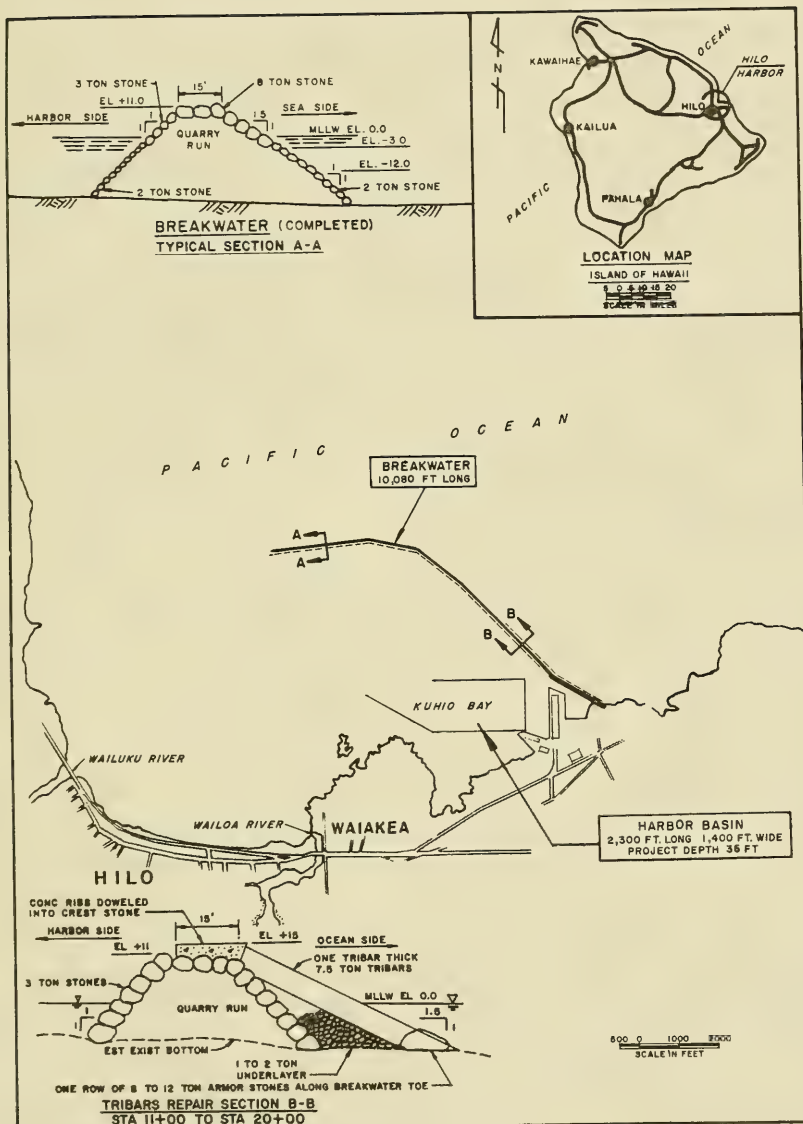
Figure 2. Hilo Harbor Breakwater, Hawaii, Hawaii

11. A repair similar in design to that used on Nawiliwili in 1959 was completed on the Hilo Harbor Breakwater, Hawaii, Hawaii (Figure 2), in 1981. One layer of uniformly placed 7.5-ton tribars was placed on the sea-side slope of the breakwater between sta 11+00 and sta 20+00. Based on knowledge gained through the failure of the Nawiliwili tribar section, a row of 8- to 12-ton buttressing stone was incorporated into the toe repair. No design guidance is presently available to aid in sizing the buttressing stone for an incident wave environment, and no model tests were conducted. For this reason, close monitoring of the repair work should be carried out after storm events. Thus, POD and the Corps as a whole will gain from prototype experience which can be used to complement the data acquired during the experimental model tests on toe buttressing stone design proposed to be carried out under this work unit.

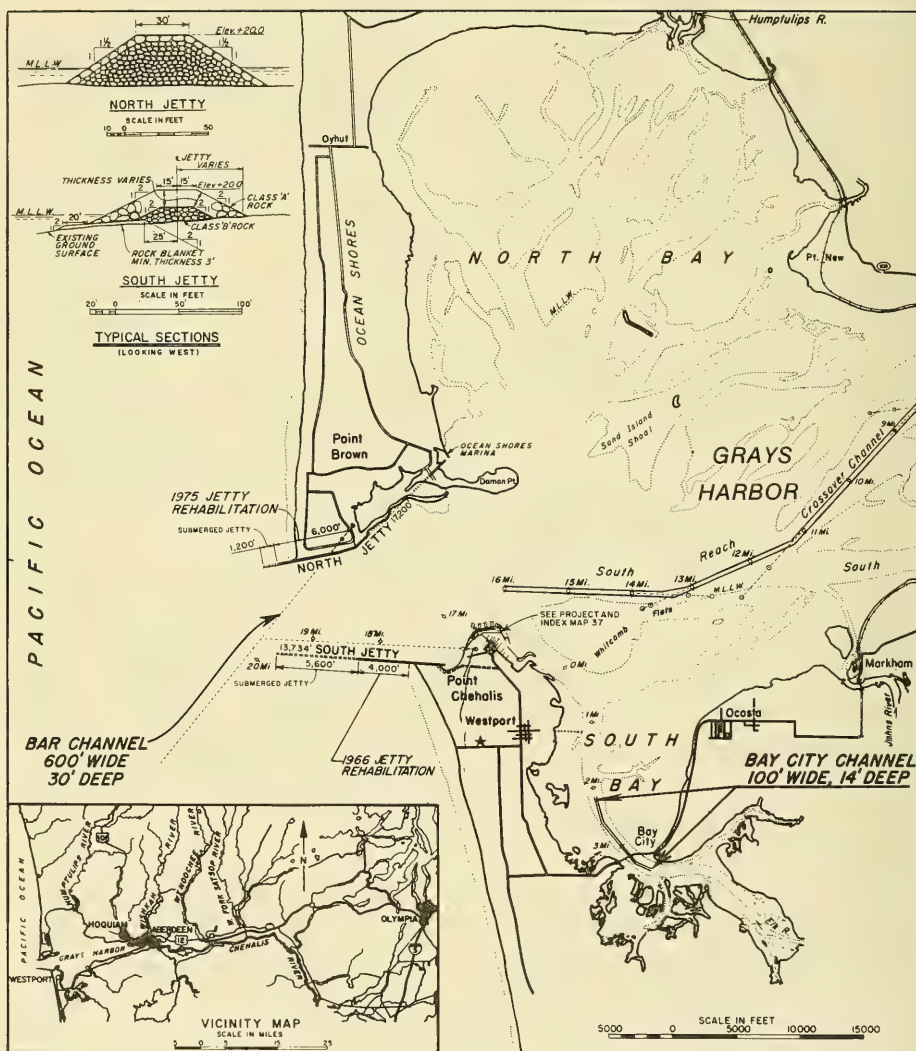
Figure 4. Grays Harbor Jetties, Washington

13. The south jetty at the entrance to Grays Harbor, Washington (Figure 4), has sustained severe scour on the channel side toe. The outer 5,600 ft of the jetty are presently below mean lower low water (mllw). It is not known if the toe scour is the cause, or a portion of the cause, of the present deteriorated condition of the jetty. Presently, no repair work is planned for the Grays Harbor Jetties.

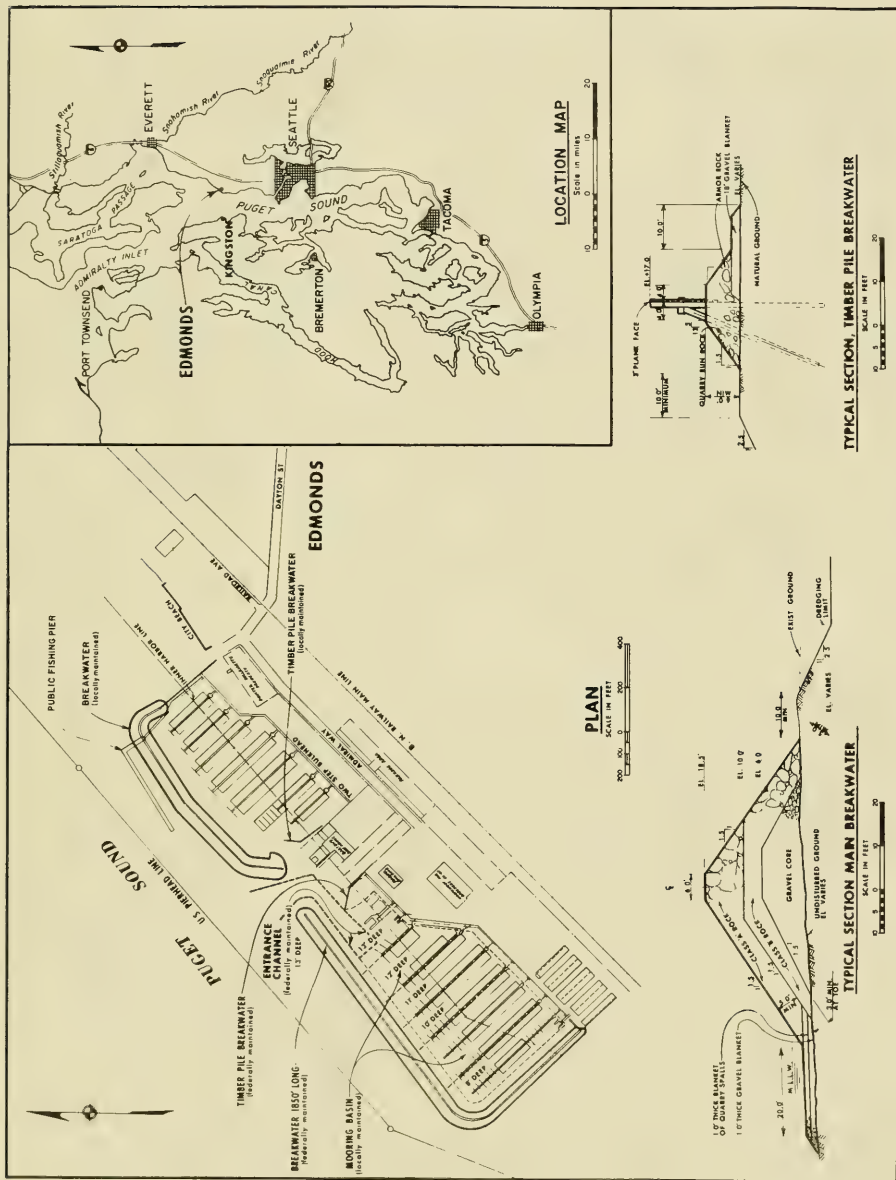
Figure 5. Edmonds Harbor Breakwaters, Washington

14. As of August 1985 plans were being developed for the repair of the rubble-mound breakwaters at Edmonds Harbor, Washington (Figure 5). It is not definitely known that toe stability was a cause of some of the existing damage, but it is thought to be a probable cause. The bottom drops off on a 1V:2H slope to a deep depth just out from the toe of the breakwaters. There is some thought that this deep water adjacent to the structure, which allows large amounts of wave energy to reach the structure, could be initiating toe stability problems. No firm decisions had been made on the repair design when this report was being prepared.

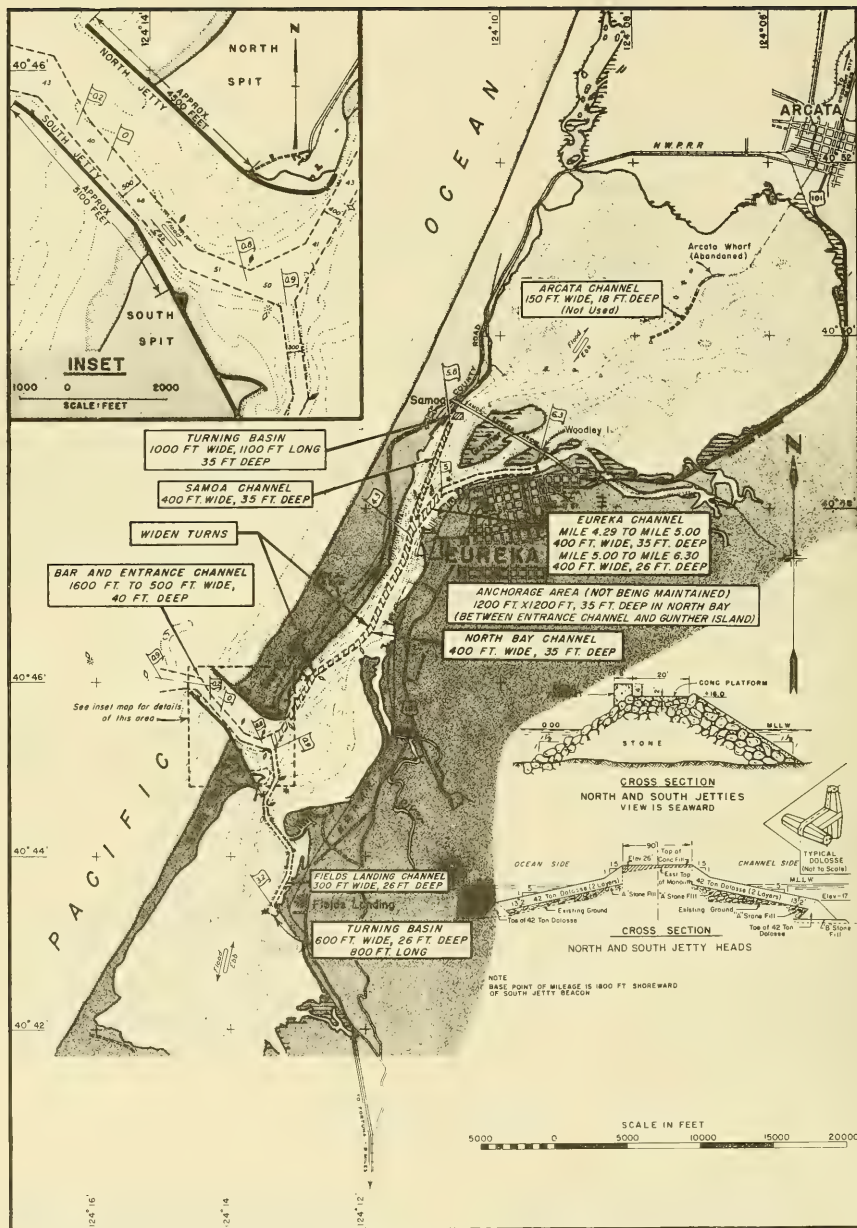
Figure 15. Humboldt Bay Jetties, California

16. The San Francisco District sited the jetties at Humboldt Bay (Figure 15) as being the only area showing obvious toe stability problems. The channel side of the north jetty and exposed side of the south jetty have shown obvious signs of scour and undermining which resulted in instability and slippage of the dolos toe. Condition surveys of the area have revealed the depths of the scour holes appear to have a seasonal fluctuation. An armor stone berm, extending from 70 to 100 ft out from the existing dolos toes, was included in the jetty repair work conducted in 1985. The multilayered berm consists of a 3- to 6-ton primary armor stone overlying two graded filter layers (Figures 16 and 17).

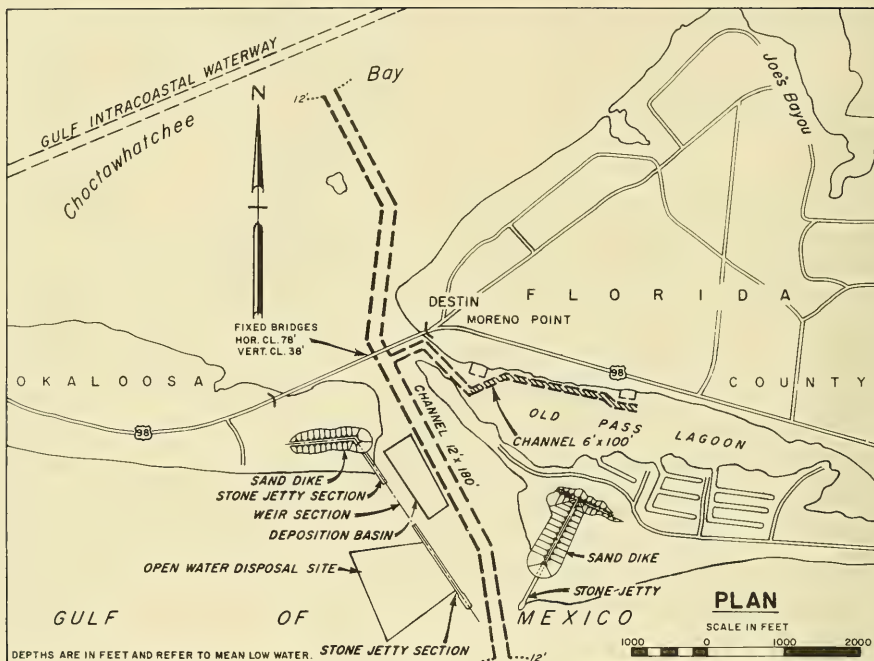
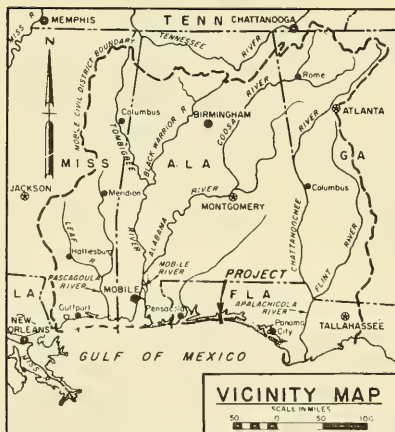
Figure 23. East Pass Channel Jetties, Florida

21. Toe scour also has been noted as a problem with the jetties at East Pass Channel and St. George Island, Florida, and Perdido Pass Channel, Alabama (Figures 23-25, respectively). Scour on the channel side of the east jetty at East Pass is so severe that it is thought that portions of the jetty may slide into the channel at any time. In the past, this type of slippage failure has caused severe damage to the west jetty at Panama City.

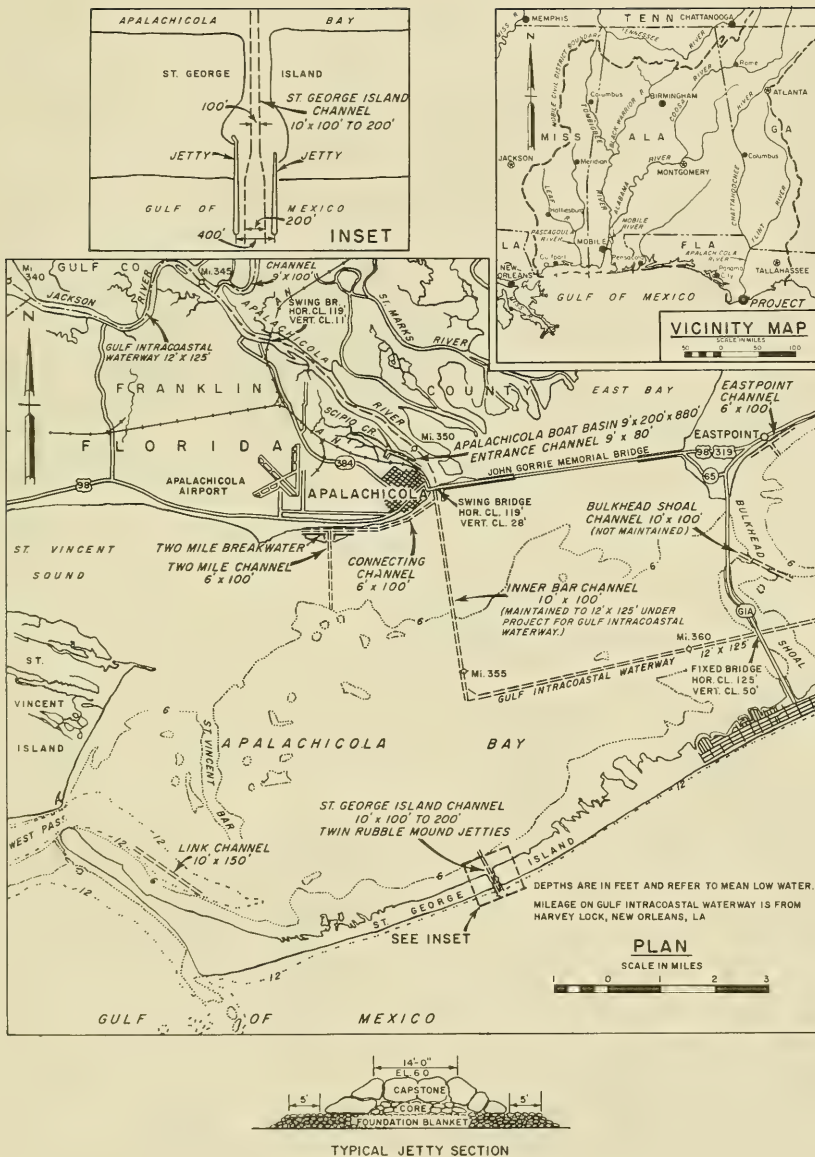
Figure 24. St. George Island Jetties, Florida

22. Jetties at St. George Island have suffered cover stone loss resulting from the undermining action of toe scour. The west jetty at Perdido Pass presently has significant amounts of toe scour on the channel side, and Hurricane Frederick produced significant amounts of toe scour on the east jetty. The overall condition of the Perdido Pass jetties was said to be good; therefore, it is assumed that the toe scour has not caused any obvious damage above the waterline.

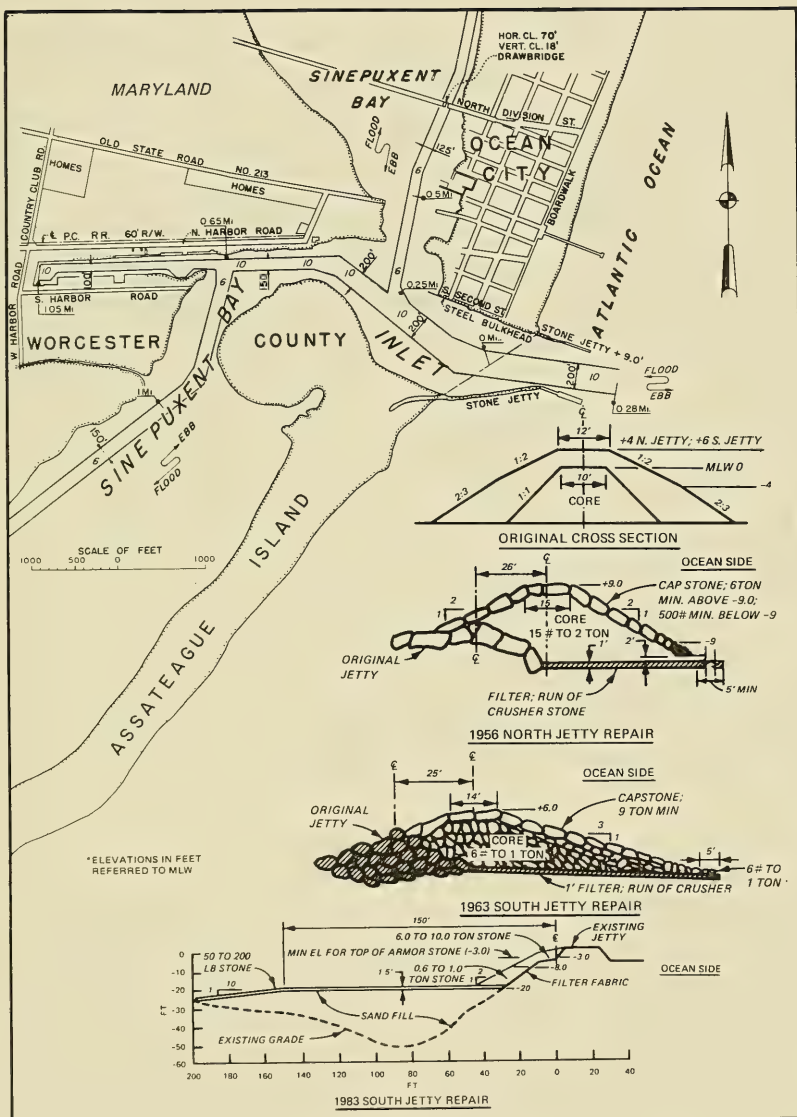
Figure 27. Ocean City Inlet Jetties, Maryland

24. The south jetty at Ocean City Inlet, Maryland (Figure 27), is the only structure within the Baltimore District that was reported as having significant toe stability problems. The original north and south jetties, both rubble mound, were constructed in 1934 and 1935, respectively. The crown elevation on the shoreward end of the north jetty had to be increased in 1937 to stop flow of sand into the inlet. The landward end of the south jetty required extensions in 1956 and 1963 to repair flanking caused by erosion. The south jetty has suffered major deterioration along its outer leg caused by ebb flow induced scour and undermining of the structure's inlet side toe. During major repair of the south jetty in 1963, the center line of the structure's repair section was offset outward from the inlet (Figure 27). This was done to alleviate the need to fill the massive scour hole that existed where the inlet side of the structure was originally constructed. The ocean side of the existing structure that remained was used as a base against which the inlet side toe of the jetty repair section was positioned. By 1982, the 1963 repair section of the south jetty was once again very deteriorated. Like the original, this damage was only on the converging portion of the jetty and was caused by ebb flow induced undermining of the structure's inlet side. In order to prevent failure of the outer end of the south jetty, which would lead to severe inlet shoaling, the scour hole adjacent to the structure was filled with dredge material and capped with stone. The lower portion of the inlet side of the jetty was overlaid with an intermediate stone size, and the remainder of the inlet side slope was covered with primary armor stone. This work was completed during 1983 to 1984, and a typical repair cross section is shown in Figure 27. The majority of the south jetty's original repair section still shows considerable deterioration and is highly overtopped. It is unknown how well the scour protection is performing. It appears that scour on the north side of the inlet has slowed down, and the north jetty is in good condition; however, the overall scour in the throat of the inlet shows no signs of stabilizing.

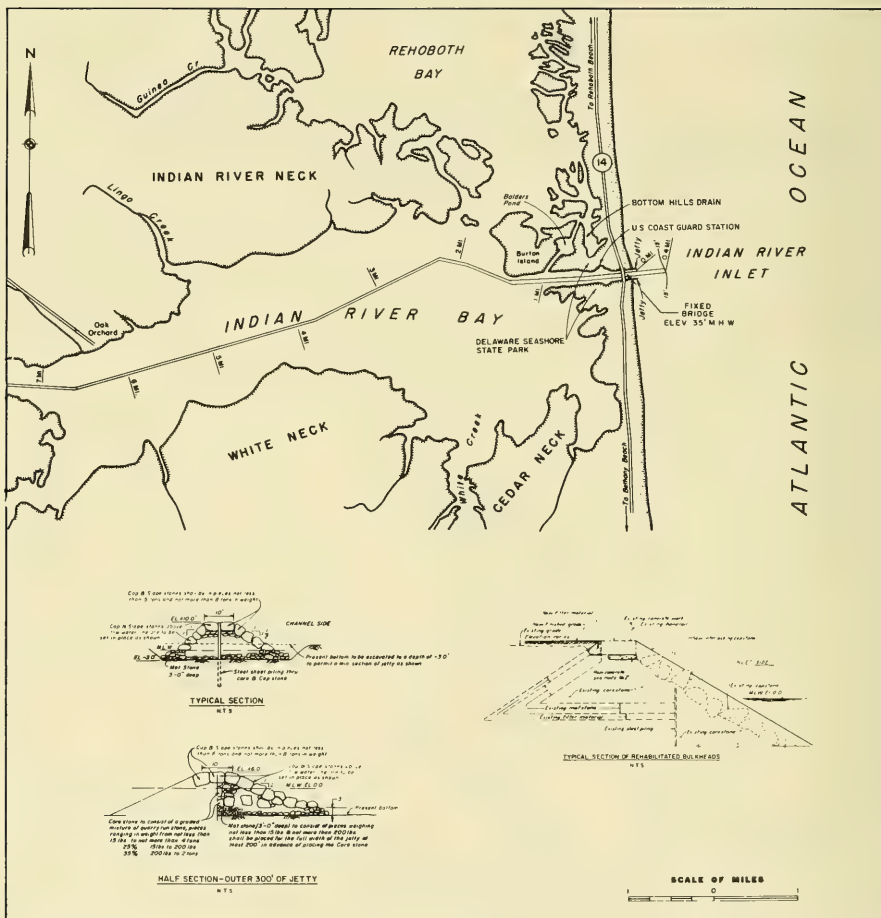
Figure 29. Indian River Inlet Jetties, Delaware

27. The rubble-mound and sheet-pile composite jetties at Indian River Inlet, Delaware, were completed in 1939 (Figure 29). The jetties required storm damage repairs in 1956 and 1957. At that time, the north jetty was extended inshore a distance of 320 ft. At present both jetties are 1,566 ft long. Both jetty heads have deteriorated significantly from a combination of toe scour, armor stone slippage and displacement, and overall subsidence. Because of the success of the Manasquan River Jetty repairs, dolosse are being considered for inclusion in the repair and rehabilitation designs for the structure slopes. No details on the proposed toe repair design are available.
